PHYSICAL/CAPITAL NEEDS ASSESSMENT

KING COURT (MR23)

East Hartford, Connecticut

June 25, 2012

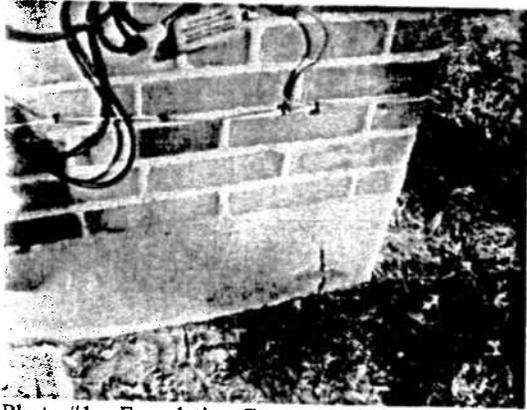
The existing concrete foundation walls appeared to be in good to fair condition with some observed cracking. *See Photo #1.* An allowance for repair of any cracked foundation walls is included in year 2.

Photo #1 – Foundation Concrete with some Cracking.

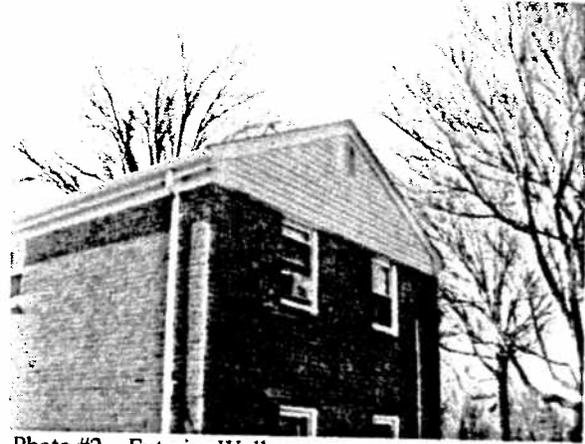
Photo #2 – Exterior Walls.

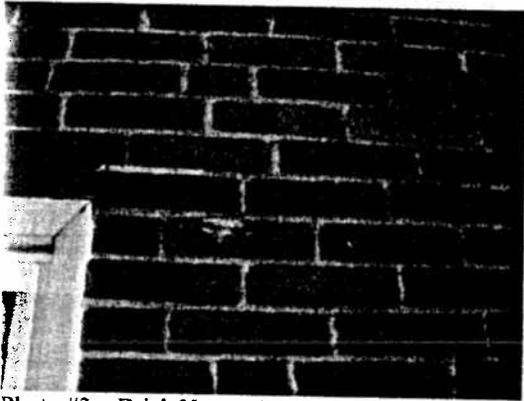
The exterior walls on all buildings are wood framed with brick veneer. Some buildings also have some vinyl siding. *See Photo #2.* The vinyl siding appears to be in good condition. No allowance is included for the vinyl siding. Some existing bricks are cracked and some mortar joints are in need of repointing in many areas. *See Photo #3.* An allowance is included in year 2 to repair and repoint masonry walls.

Photo #3 – Brick Veneer Wall showing some Cracking.

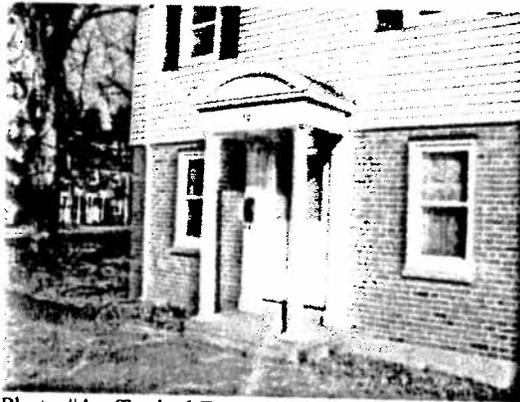
The existing roof is an asphalt shingles system reported to have been installed in 1998. It was also reported all leaks have been repaired. However, these roofs are in need of replacement because they are at the end of their useful life. An allowance is included to replace these roofs in year 2. It was reported that some of the entrance canopies have deteriorated, leak and are pulling away from the building. *See Photo #4.* An allowance to renovate or repair these canopies is included in year 3.

Photo #4 – Typical Entrance Canopy.

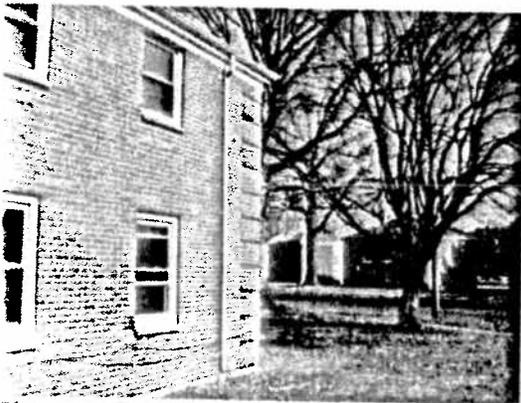
Roof drainage is accomplished by existing aluminum gutters and aluminum downspouts. These gutters and downspouts are in average condition, with some missing end spouts. *See Photo #5.* The existing gutters and downspouts should be replaced and new gutter guards installed when roof replacement occurs. An allowance to replace these gutters and downspouts is included in the roof replacement allowance in year 2.

Photo #5 – Typical Aluminum Gutter and Downspouts.

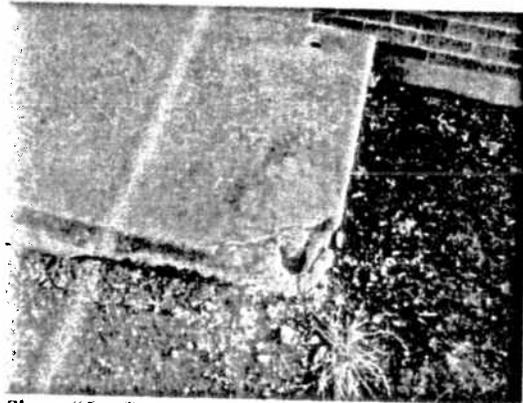
The existing door stoops at the front and back exterior doors are concrete. *See Photo #6.* These stoops appear to be in fair condition with some deterioration observed. An allowance is included in year 5 to replace these concrete stoops.

Photo #6 – Concrete Door Stoop with Deterioration.

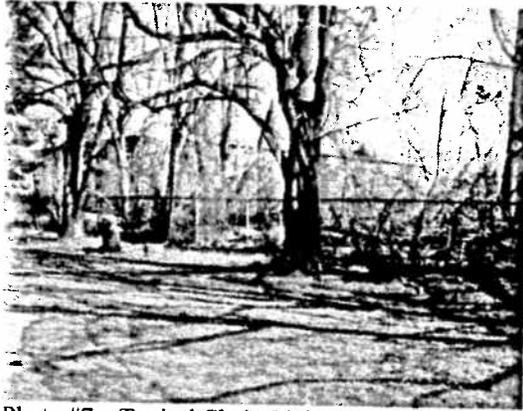
Existing chain link fence was observed along the property line of this development. It appears that some repairs/replacement of this fence has occurred. *See Photo #7.* The remaining fencing is nearing its useful life and should be replaced. Fence replacement is included year 6.

Photo #7 – Typical Chain Link Fence.

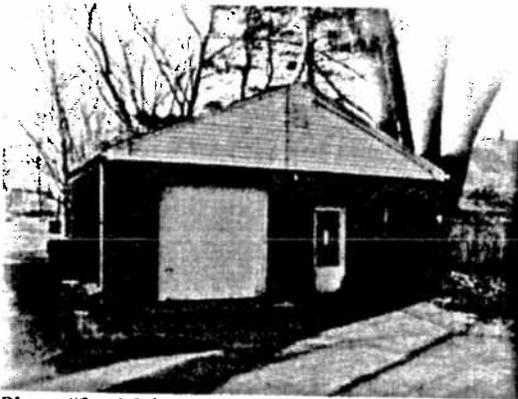
The existing exterior doors in the maintenance building consist of an overhead door and an entrance door. Both of these doors will exceed their useful life during the term of this report. *See Photo #9.* An allowance is included to replace these doors in year 2.

Photo #9 – Maintenance Building.

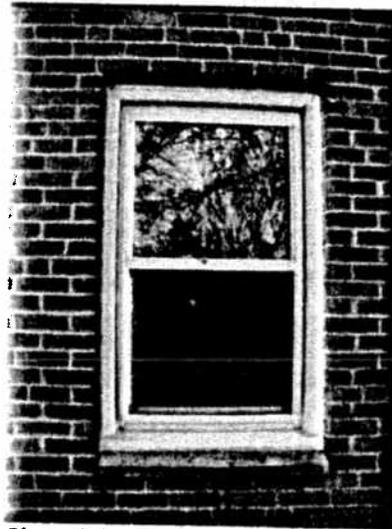
The existing metal double hung windows are old, inefficient and beyond their useful life. *See Photo #10.* An allowance is included to replace these windows in year 1. The basement windows appear to be original and are beyond their useful life. An allowance to replace these windows is also included in year 1.

Photo #10 – Typical Window.

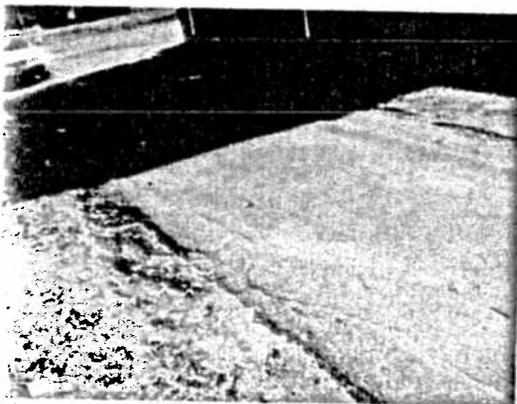
There are asphalt driveways adjacent to each building. *See Photo #11.* These driveways are in average to poor condition. An allowance is included to replace these asphalt driveways in year 3.

Photo #11 – Typical Bituminous Driveway.

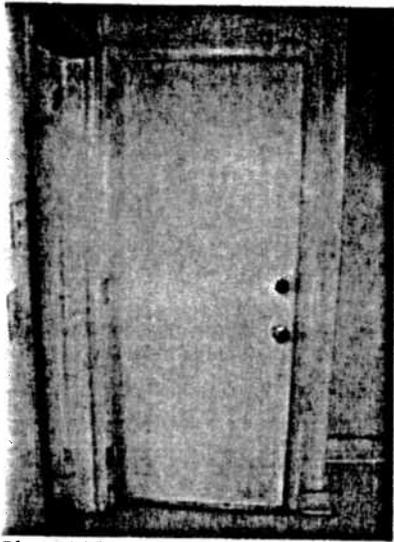
The dwelling unit entrance doors appeared to be mostly original doors. *See Photo #13.* These doors have exceeded their useful life and should be replaced. An allowance is included in year 8 to replace these doors and door hardware. Most of the unit interior wood doors observed appeared to be original and have exceeded their useful life. An allowance is included to replace these interior doors when the entire units are renovated, see item #46.

Photo #13 – Typical Dwelling Unit Entrance Doors.

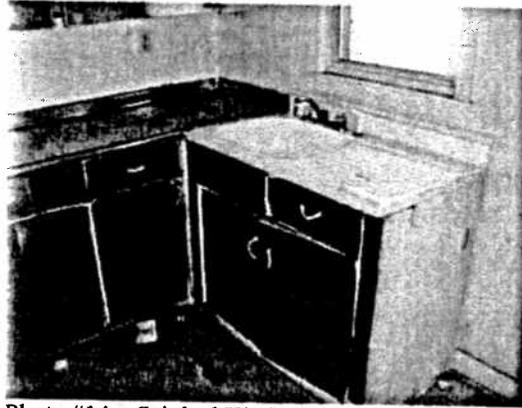
The kitchen cabinets were original in most units observed. *See Photo #14.* However, some units have new or fairly new cabinets and p.lam countertops. Also, some vacant units observed do not have kitchen cabinets. The original cabinets are in poor condition and should be replaced when the entire units are renovated, see item #46. The newer cabinets should remain.

Photo #14 – Original Kitchen Cabinets.

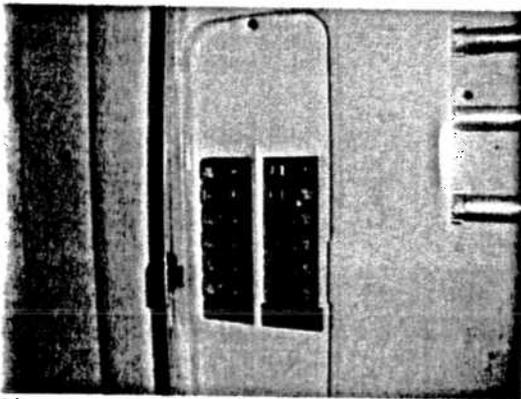
Photo #15 – Typical Unit Electrical Panel.

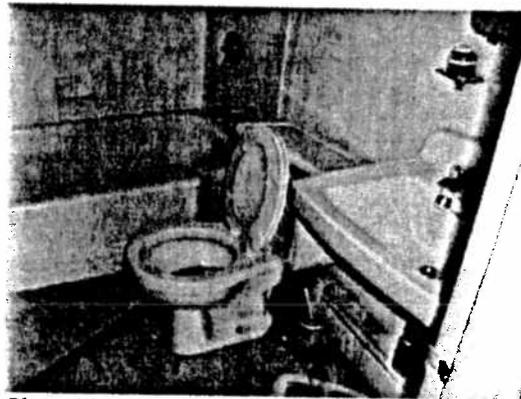
The bathroom fixtures in the unit bathrooms include a sink, toilet and porcelain tub with ceramic tile tub surround. *See Photo #16*. All fixtures observed were in fair to poor condition. The Housing Authority would like to eliminate the existing window within the tub areas for maintenance reasons. Toilet bathroom renovations is recommend including replacing the sink, toilet, tub, tub surround, flooring, eliminating the window, installing a wall mounted fan, painting the walls and ceiling, at the same time as the total unit renovation, see item #46.

Photo #16 – Typical Unit Bathroom.

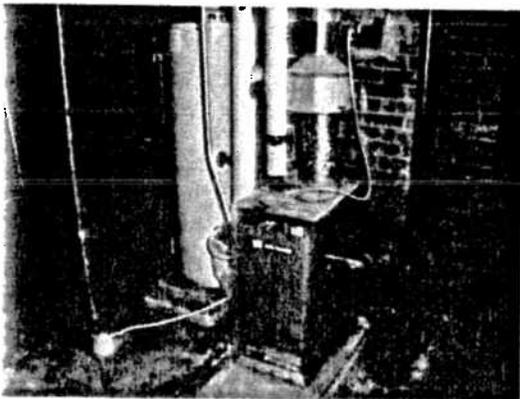
Heating for the dwelling units is provided by hydronic baseboard heating elements feed from individual gas fired boilers located within the basements of each building/unit. *See Photo #17*. These boilers are controlled by thermostats located within each unit. It was reported that these boilers are 15+ year old. They will exceed there useful life during the term of this report. An allowance is included in year 4 to replace these boilers. The Housing Authority does not supply air conditioning to the dwelling units. No allowance is included for air conditioning.

Photo #17 – Typical Unit Boiler.

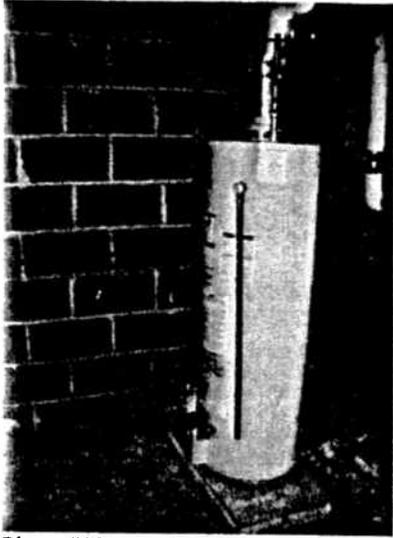
The hot water needs for each dwelling unit are furnished by existing 40 gallon gas fired hot water heaters located in the basement. *See Photo #19*. These hot water heaters vary in age. It was reported that they are presently replaced on an "as needed" basis. The cost to replace all the existing hot water heaters is included within the cost to replace the gas boilers in year 10.

Photo #19 – Typical Unit Water Heater.
